**Report Number 05-03**

**Historic Context and Detailed Documentation of the Main Canyon  
Ditch, Town Ditch, Comanche Dam (42WS4376), and Comanche  
Ditch (42WS2507), New Harmony, Washington County, Utah**

August 2005

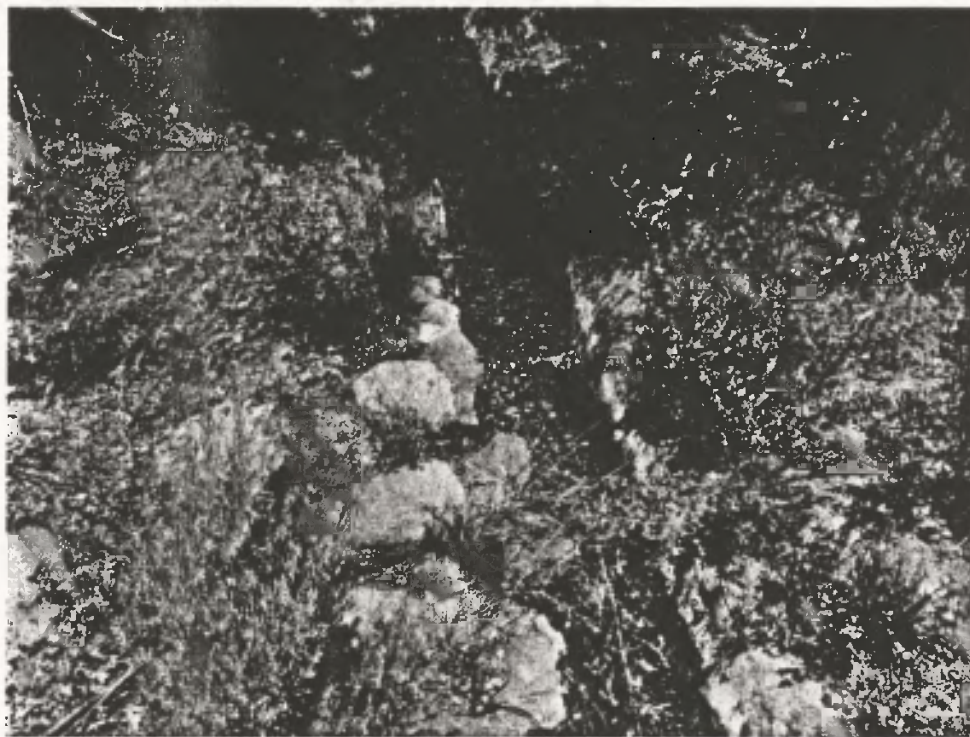
**Figure 3. Comanche Ditch (42WS2507)**

The Work Projects Administration (WPA) constructed the Comanche Ditch most likely in 1935 / 1936 to bring water from Comanche Spring, located along the eastern foothills of the Pine Valley Mountains, to the Town of New Harmony. The ditch originates at Comanche Spring within T 38S, R 13W, Section 17 on land administered by the U.S. Forest Service – Dixie National Forest at an elevation of approximately 5790 ft. From this point the ditch proceeds southeast onto the proposed project area within T 38S, R 13W, Section 21 to an elevation of about 5379 ft. where it joins the Town Ditch. A total length for the ditch is roughly 2350 m (1.46 mile). The ditch is not depicted on the New Harmony 7.5' topographic quadrangle map dated 1986 and was not indicated on GLO maps of the area, however it is visible on aerial photos (Figure 4).

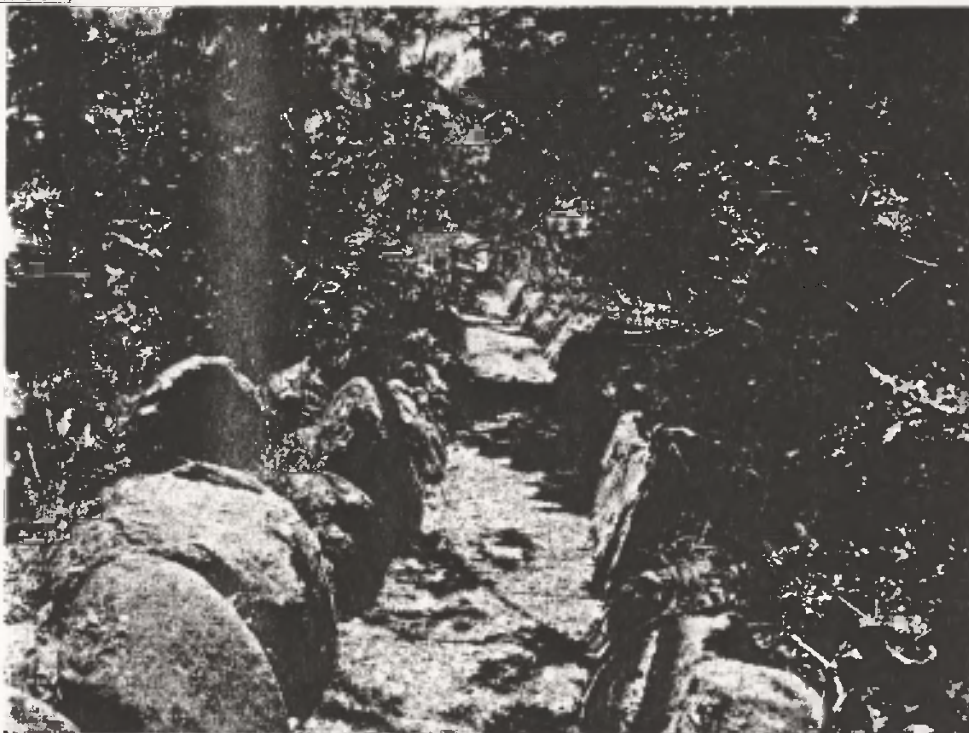
Figure 7. Main Canyon Ditch (42WS4376) with large rocks along its sides

The Main Canyon ditch was also constructed by the WPA around 1935 / 1936. This ditch was constructed prior to the Comanche Ditch, as indicated by personal interviews with local informants (see below), to bring water from the Pine Valley Mountains to the Town of New Harmony. An origination point for the ditch is up Main Canyon, however its exact origin is not known and it is not depicted on topographic / GLO maps of the area. The ditch is visible on aerial photographs of the area and is indicated in Figure 9.

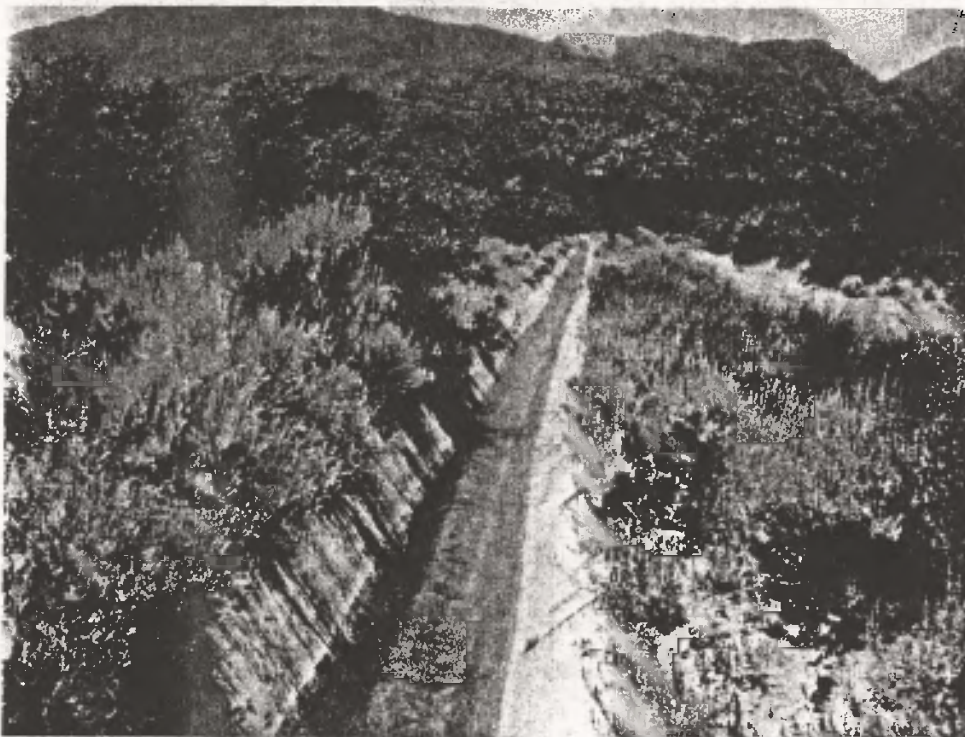
**Figure 10. Concrete lined Town Ditch (42WS4376)**

The Town Ditch, as it appears today, seems to have been constructed between 1946 and 1948 (BLM 2004), although an earlier earthen ditch completed in 1865 may have existed in this location and was simply upgraded to include the concrete lining (WPA n.d.). The ditch is concrete lined ditch with a "V" shaped profile (Figures 10 & 12; Appendix A). Its origin is at the Comanche Dam (discussed below) within T 38S, R 13W, Section 21 at an elevation of about

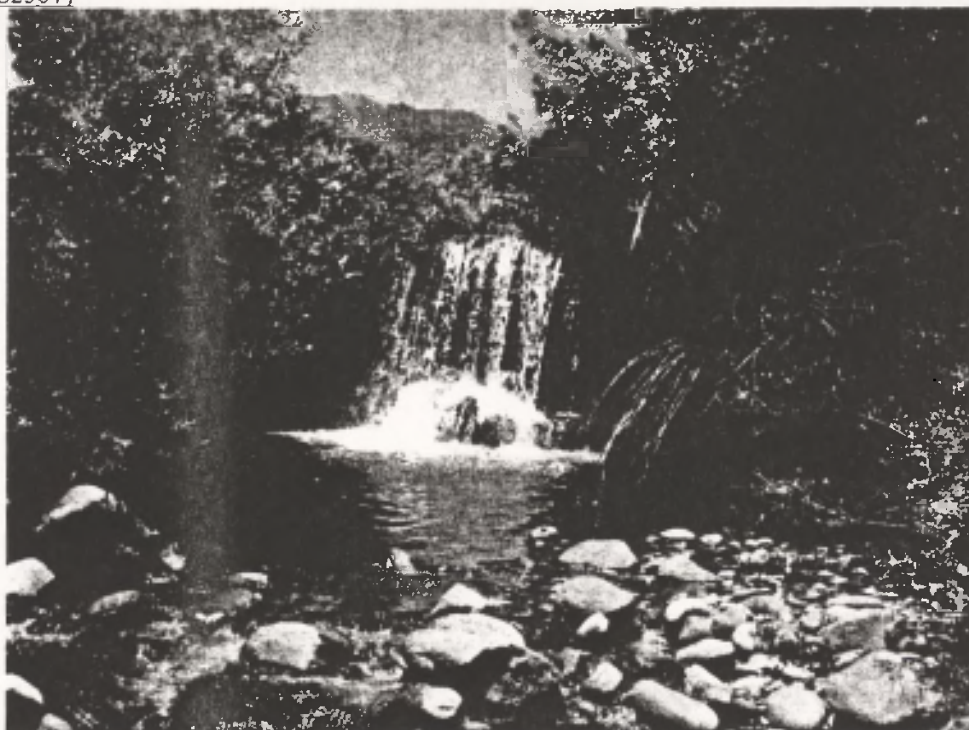
The Comanche Dam is a rock structure with concrete cap that was constructed at the confluence of Straight Canyon and Comanche Creeks within T 38S, R 13W, Section 21 at an elevation of 5380 ft. (Figure 2). The feature appears to have been built as a crossing point over the creeks and as a catchment area for the ditch system. A large corrugated metal pipe is present near the base of the feature to allow some of the water from Comanche Creek to pass through. The dam is about 10 ft. tall and 15-20 ft. wide and constructed of broken rock (Figure 13; Appendix A).

Figure 13. Comanche Dam (42WS4376)

The Comanche Dam was also constructed as part of the WPA projects in the area and was supervised by Marion after completion of the Comanche Ditch. This feature entailed breaking up rock that was used to construct an approximately 5 ft. high wall across the existing creek and placing a concrete cap across its top, forming a cap.

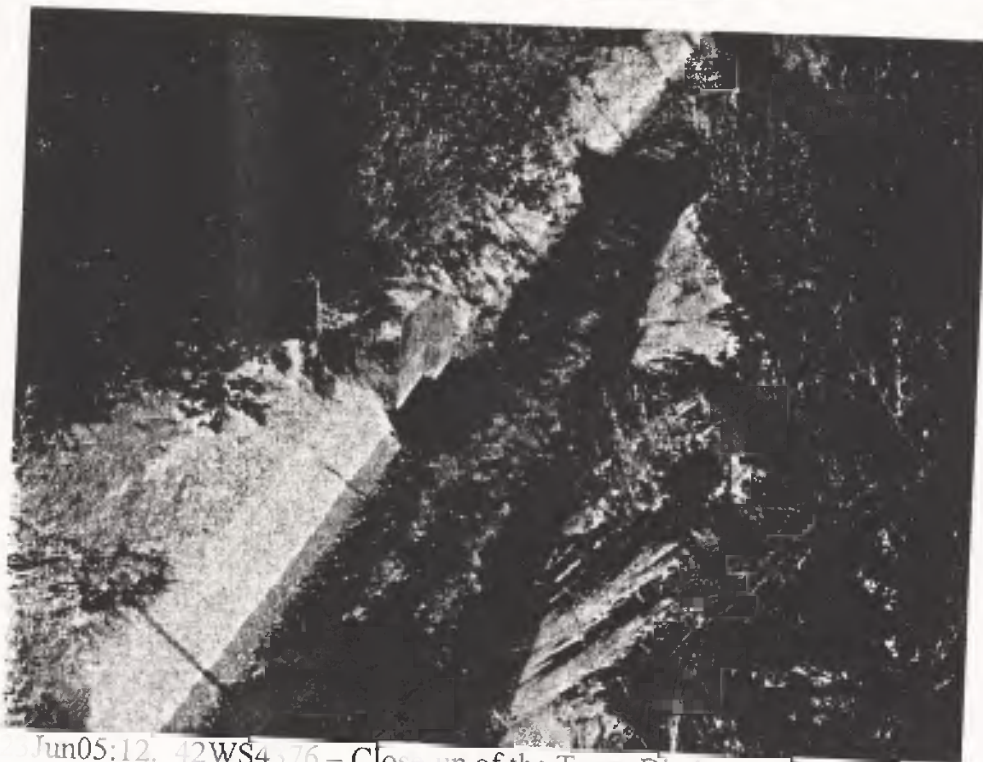
23Jun05:12. 42WS4576 - Close-up of the Town Ditch at southern-most removed headgate location

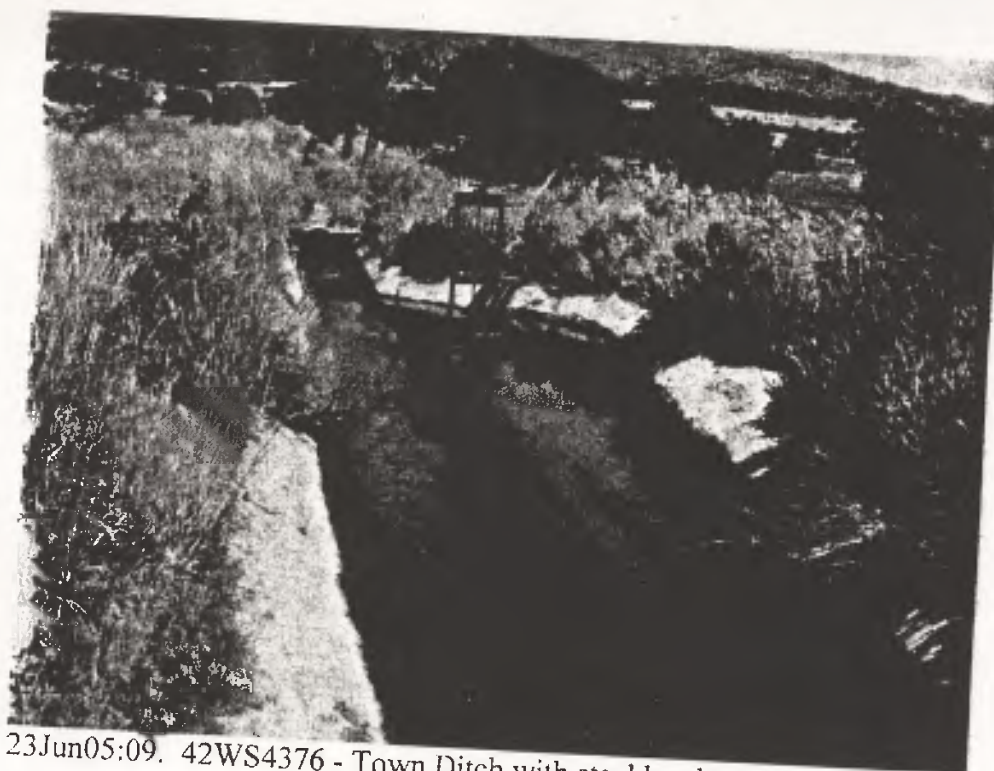
23Jun05:09. 42WS4376 - Town Ditch with steel headgate looking North-Northeast

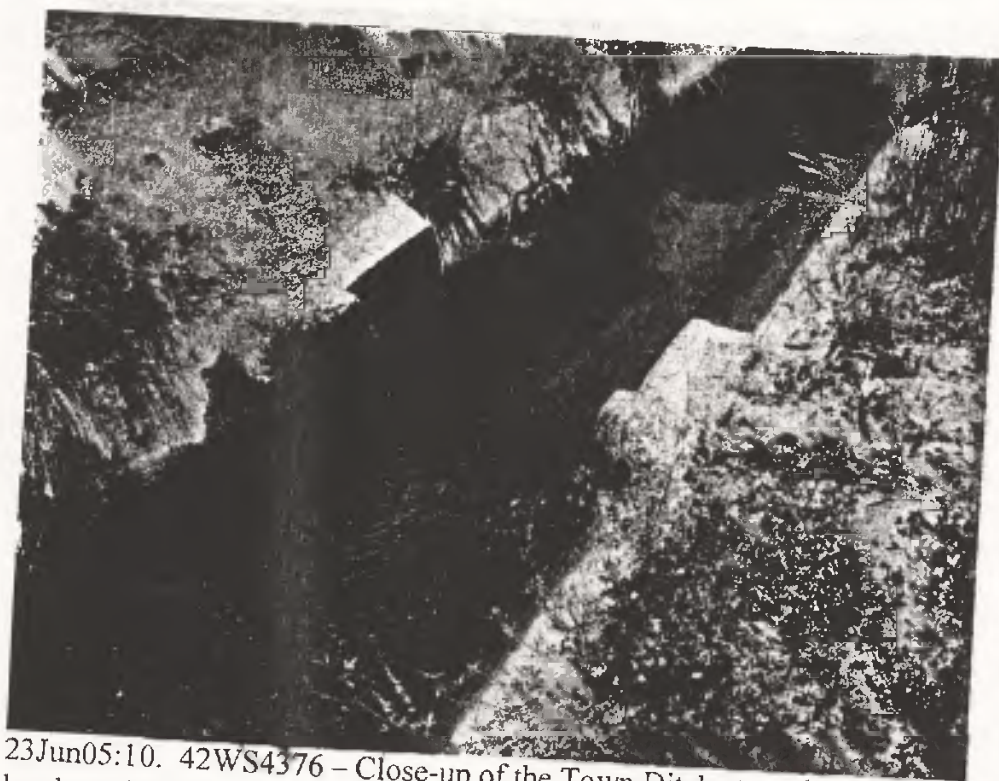
23Jun05:10. 42WS4376 - Close-up of the Town Ditch at northernmost removed headgate location

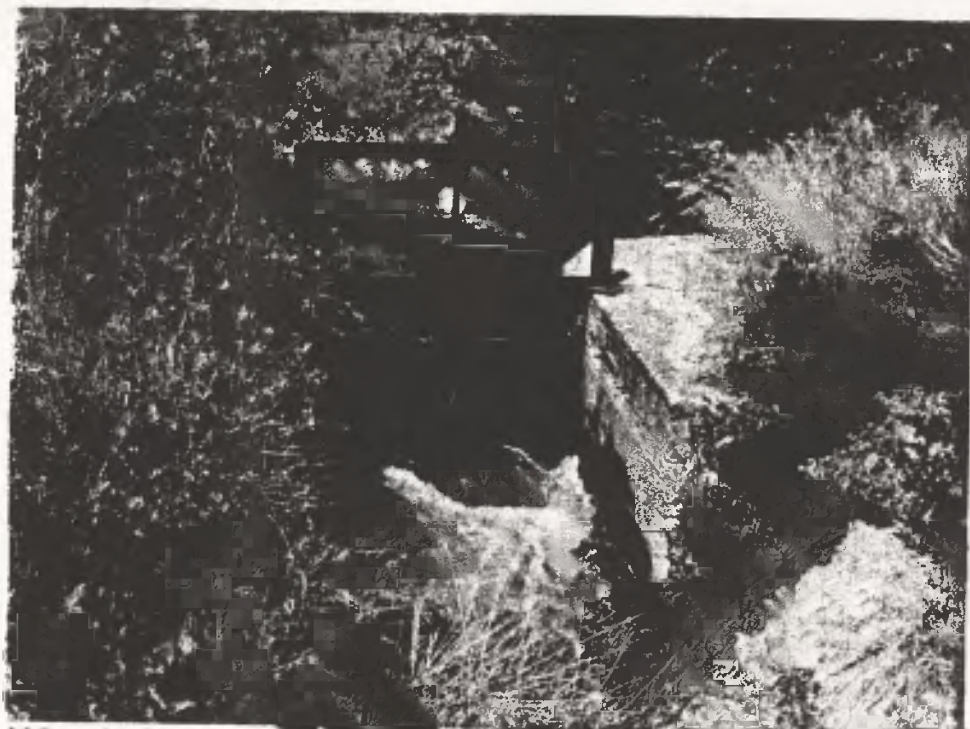
23Jun05:07. 42WS4376 -- Steel headgate on the Town Ditch looking West-Southwest

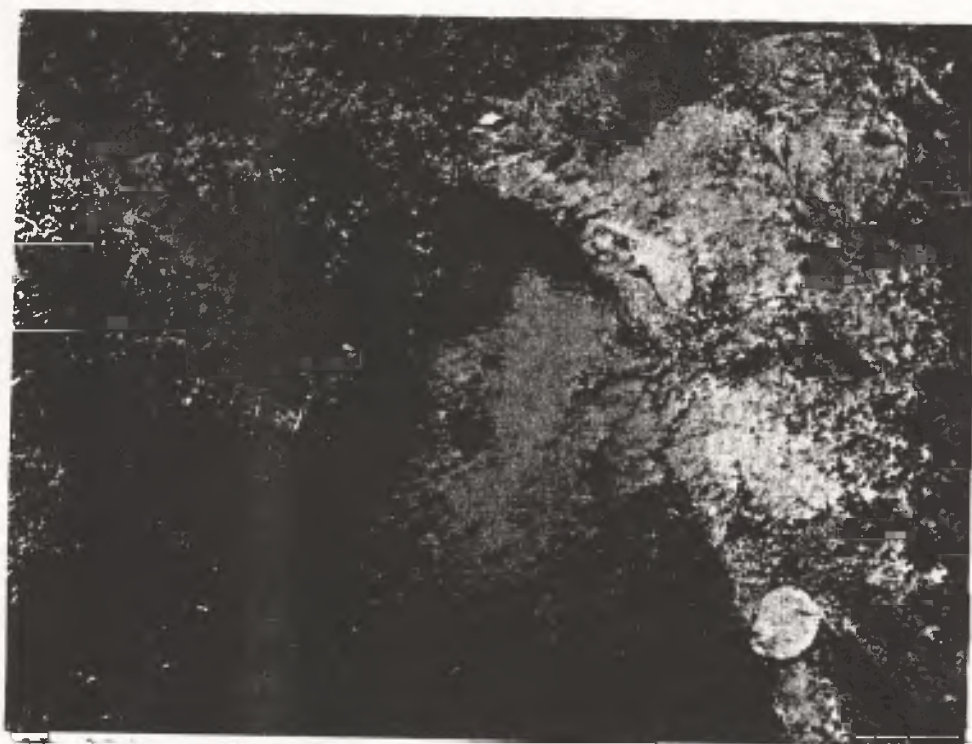
23Jun05:08. 42WS4378 -- Earthen section of the Town Ditch looking Southwest

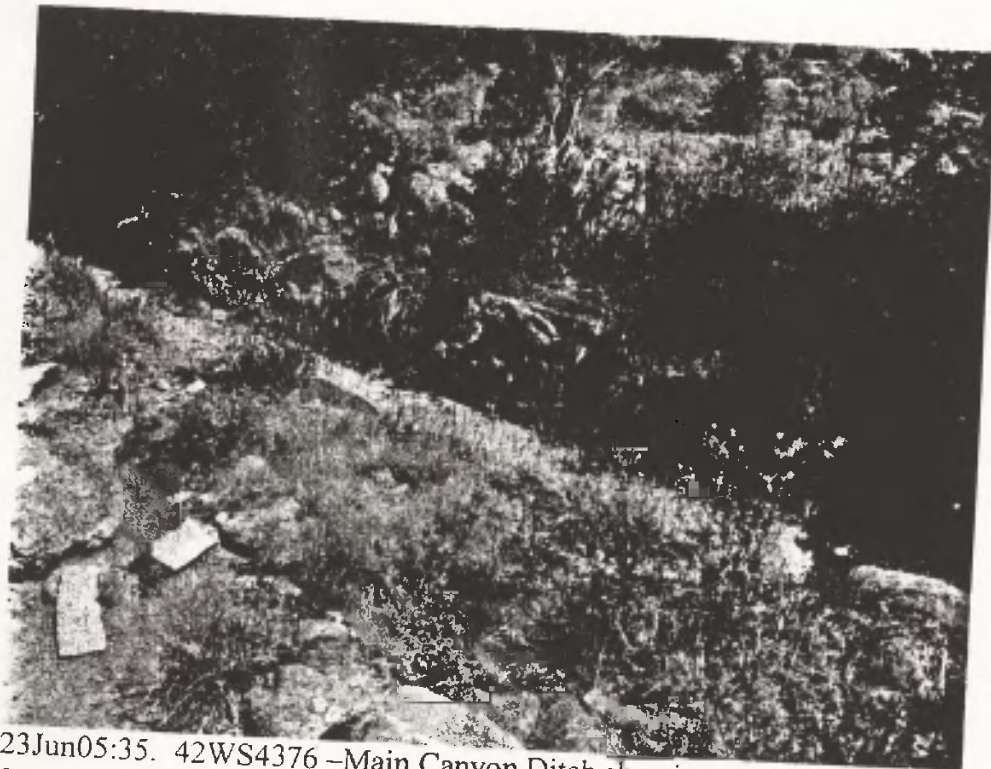
23Jun05:35. 42WS4376 -Main Canyon Ditch showing construction detail looking South
